# **INDOOR AIR QUALITY ASSESSMENT**

**Nelson Place Elementary School  
35 Nelson Place  
Worcester, Massachusetts**

Prepared by:  
Massachusetts Department of Public Health  
Bureau of Environmental Health Assessment  
December 2002

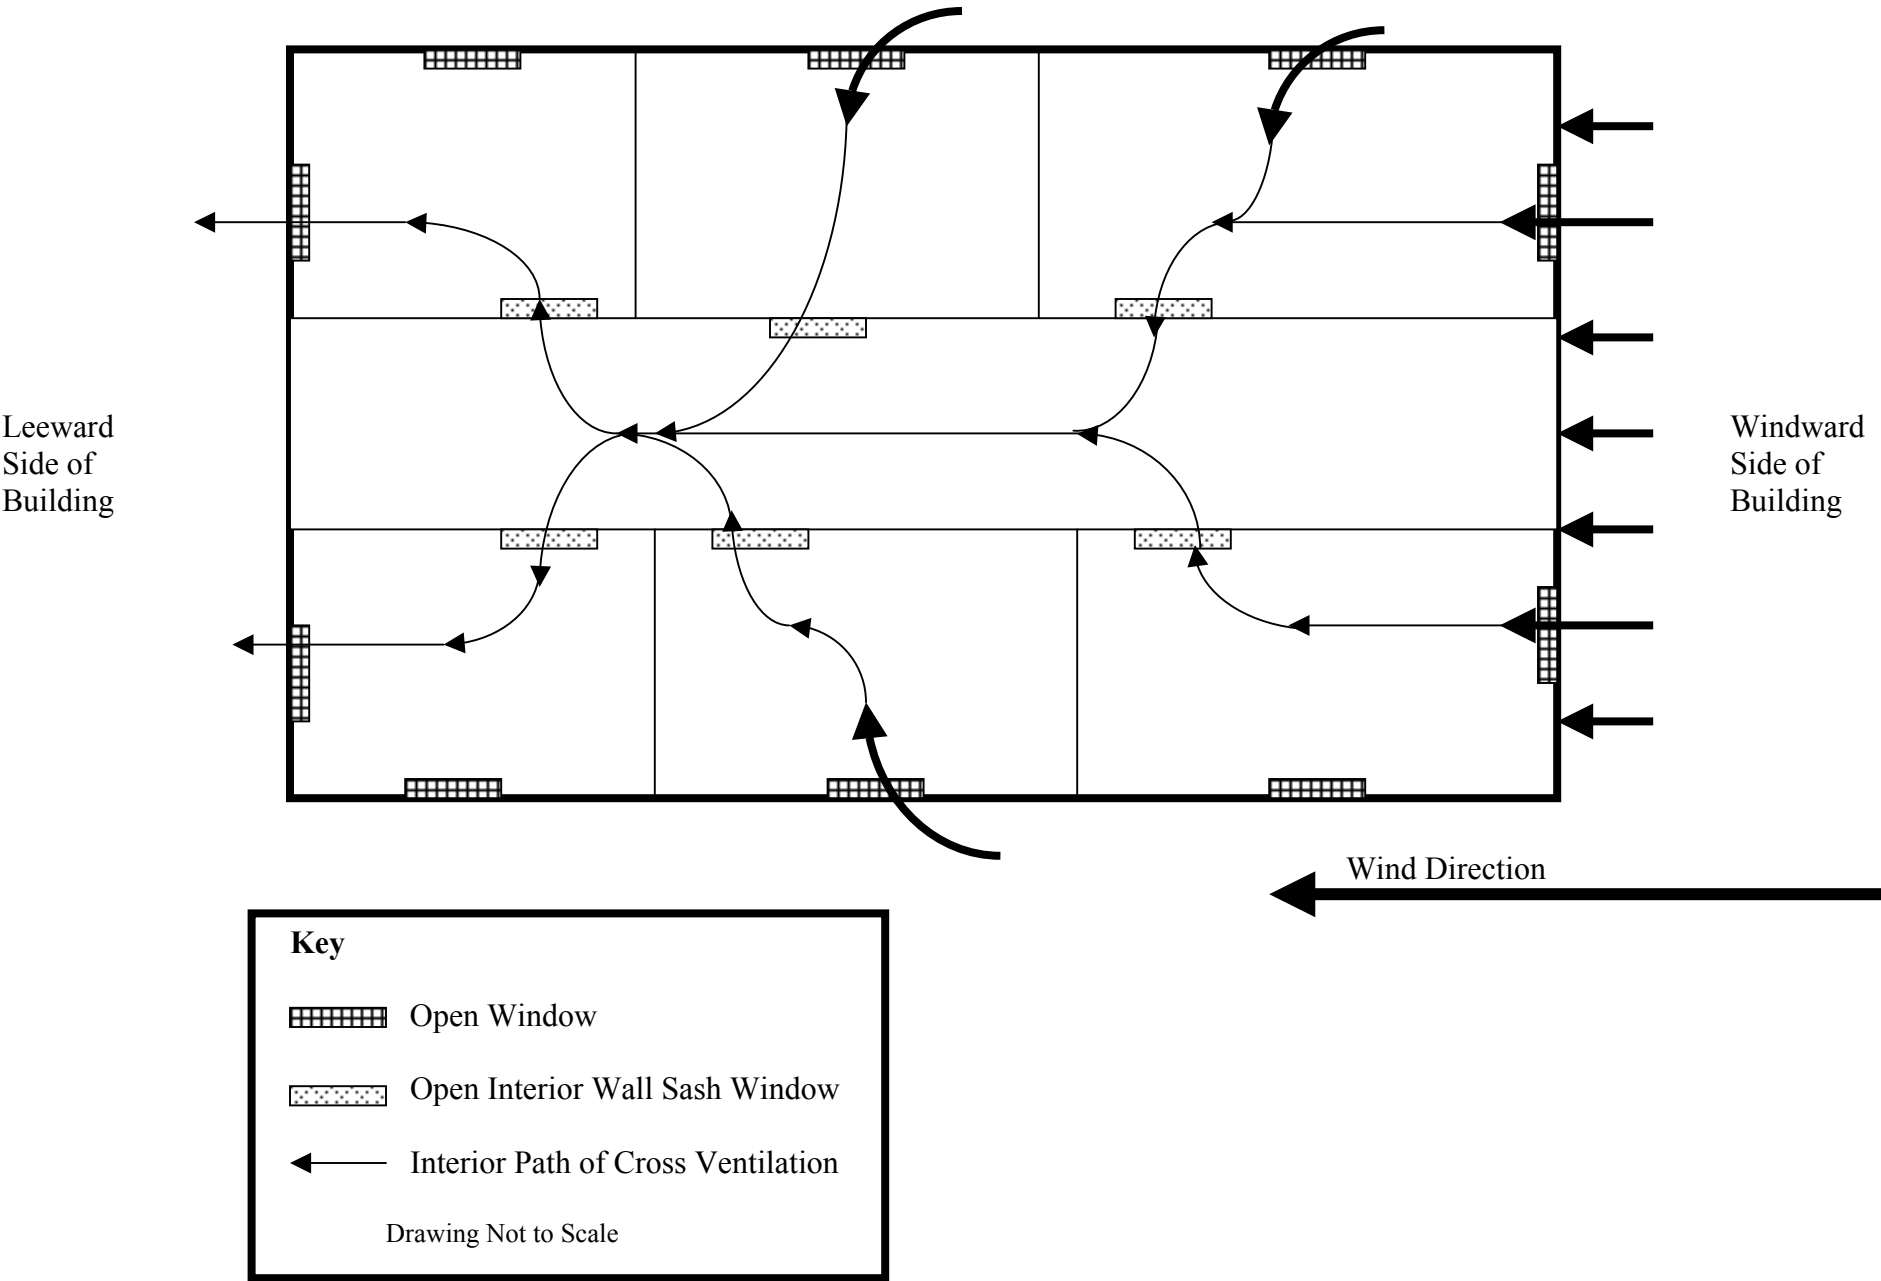
Figure 2

Cross Ventilation in a Building Using Open Windows and Hallway Doors

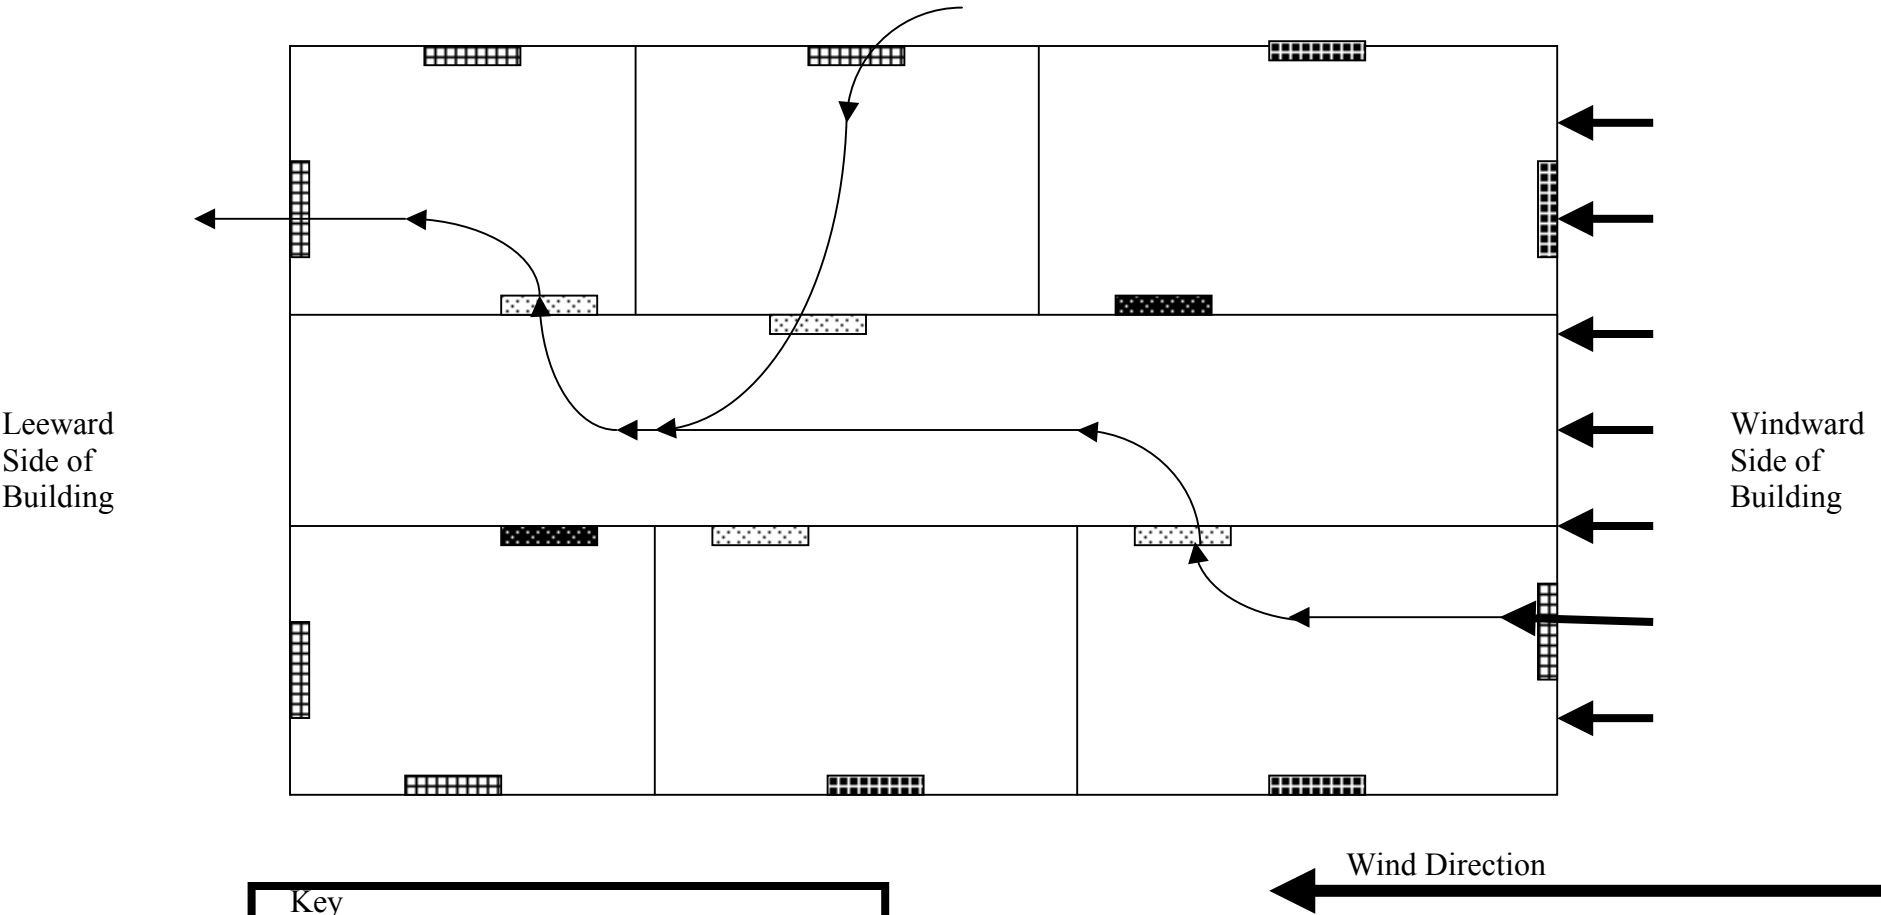
Figure 3

Please note that this ventilation system design does not operate when the heating system is deactivated during warm weather. During summer months, ventilation within this wing is controlled by the use of openable windows in classrooms. This section was configured in a manner to use cross-ventilation to provide comfort for building occupants. In addition, the building has a sash window located in the classrooms interior wall (see Picture 5). This sash window enables the classroom occupant to close the hallway door while maintaining a pathway for airflow. The building is equipped with windows on opposing exterior walls. This design allows for airflow to enter an open window, pass through the open hallway door, pass through the open interior wall sash window, enter the hallway, pass through the opposing open interior wall sash window, into the opposing classroom and exit the building on the leeward side (opposite the windward side) (see Figure 2). With all windows and the interior wall sash window open, airflow can be maintained in a building regardless of the direction of the wind. This system fails if the windows or interior wall sash window are closed (see Figure 3). A number of hallway doors were closed during the assessment, which can inhibit airflow in the summer.

Inhibition of Cross Ventilation in a Building with Several Windows and Hallway Doors Closed

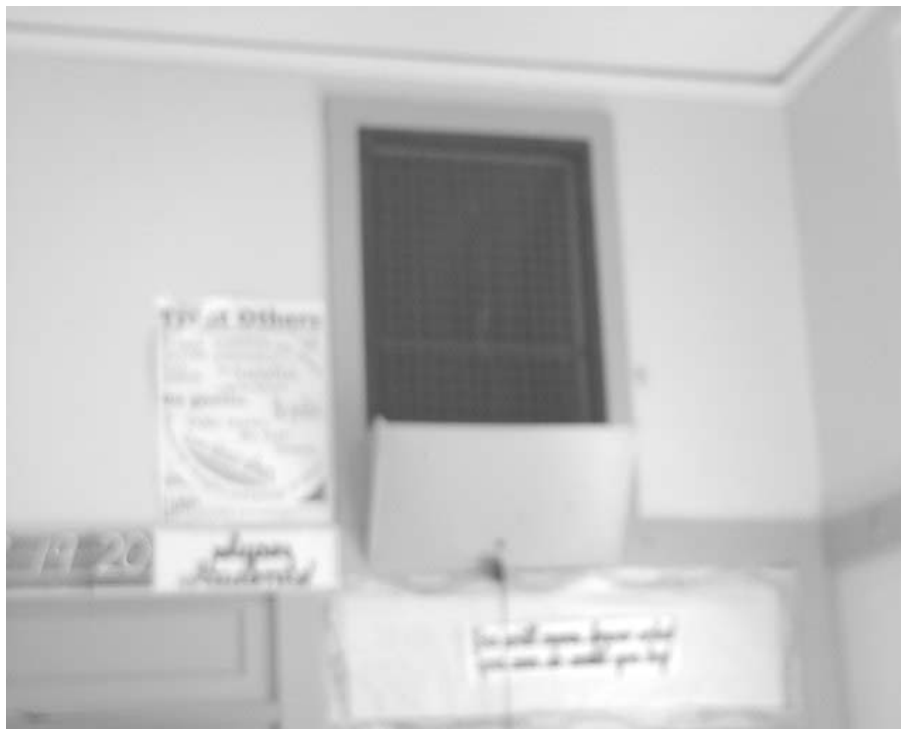
**Picture 1**

This structure appears to be constructed as a freestanding building with a different design than the rest of the complex. Ventilation was provided by a series of louvered vents. Each classroom has an approximately 3' x 3' grated air vent in the center of an interior wall near the

ceiling (see Picture 1) which is connected by a ventilation shaft to a vault-like room in the basement (see Picture 2). A corresponding 3' x 3' vent exists in each room near the classroom doorway (see Picture 3) that is connected to an exhaust ventilation shaft that runs from the roof to the basement. Classrooms were constructed around these shafts to provide exhaust ventilation.

**Fresh Air Supply, Original Wing**

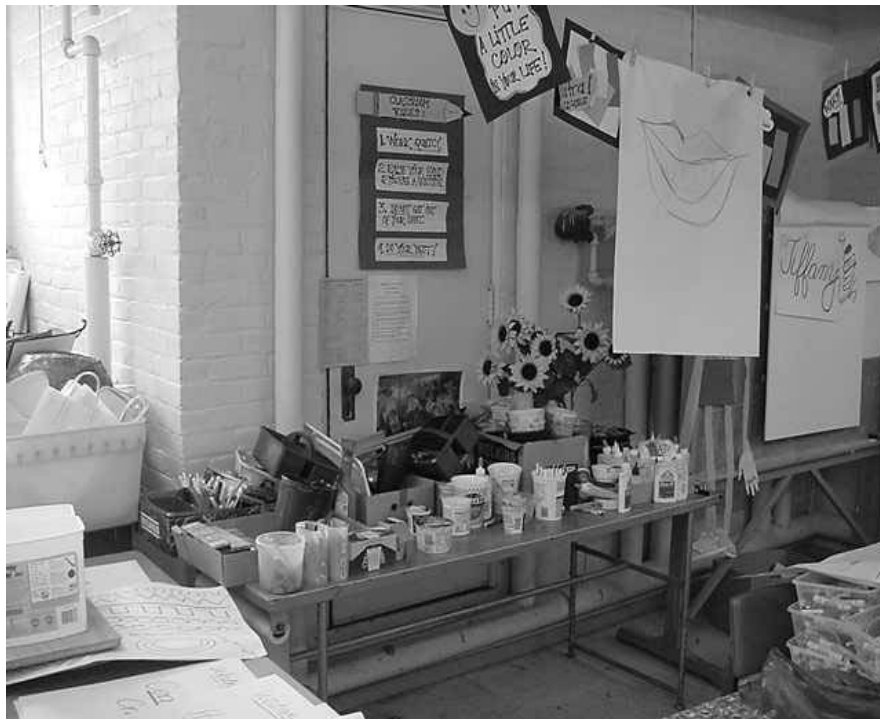
**Picture 2**

**Door to Ventilation System Vault, Original Wing**

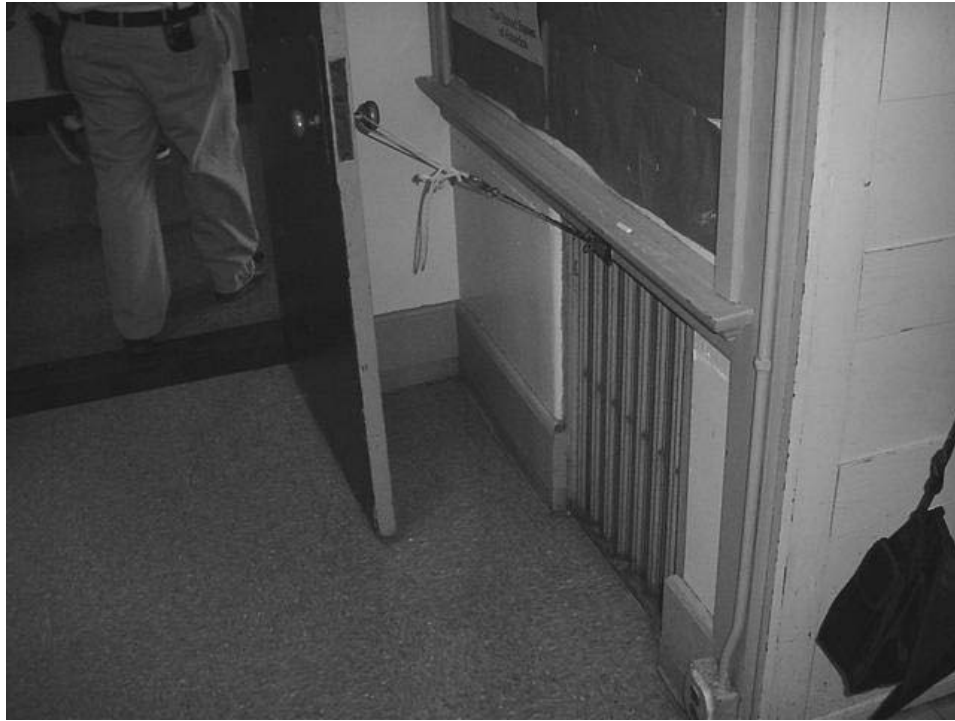
**Picture 3**

In addition, many of the control mechanisms for the natural ventilation system are not operable (see Picture 3) or are missing (i.e., pull chains and louvers) and the window systems that provided fresh air in the basement do not open. Unless the ventilation system is restored to its original design by restoring control systems, openable basement windows and unsealing of exhaust vents, the sole source of ventilation in the building is openable windows.

**Exhaust Vent, Original Wing, Note that Louver Pulley/Chain Is Tied To Hallway Door**

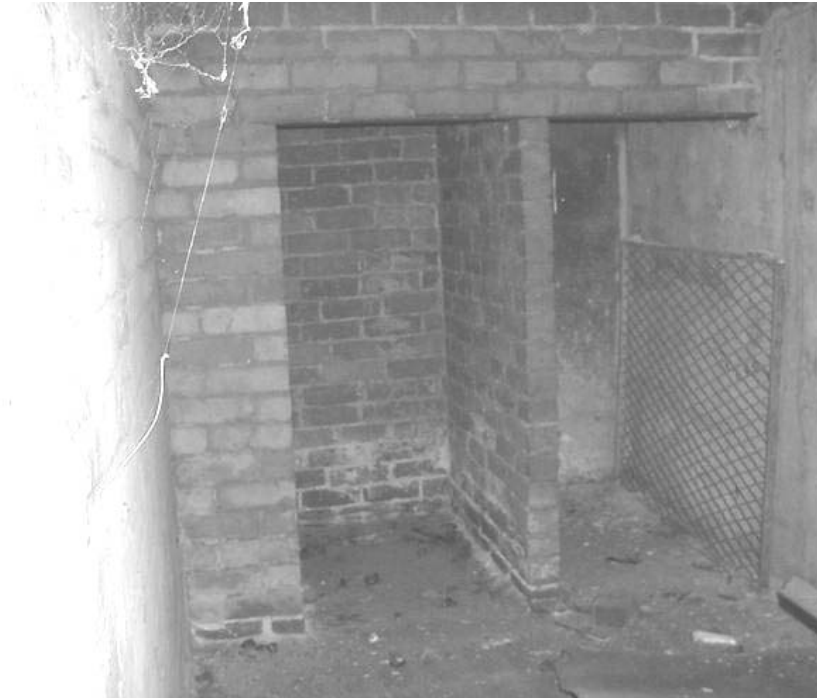
**Picture 4**

The negative pressure created by the fresh air supply system also provides classroom exhaust ventilation. Each classroom is connected by ventilation shafts to the basement beneath the heating elements in hearth-like structure shafts (see Picture 4). As the heating elements draw air into the hot air ducts, return air is drawn from the "hearths" at the bottom of the exhaust ventilation shafts. Negative pressure is created in these shafts, which in turn draw air into the exhaust vents of each classroom. The draw of air into these cool air vents is controlled by a draw

**Hearth-Like Structure in Air Handling Vault, Original Wing**

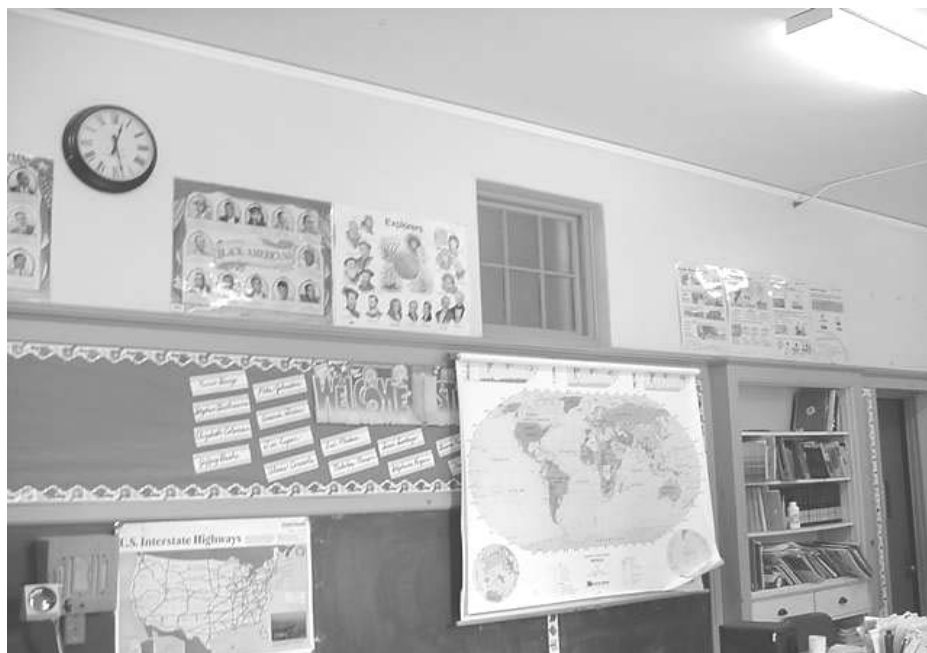
**Picture 5**

**Interior Wall Sash Window, Original Wing**

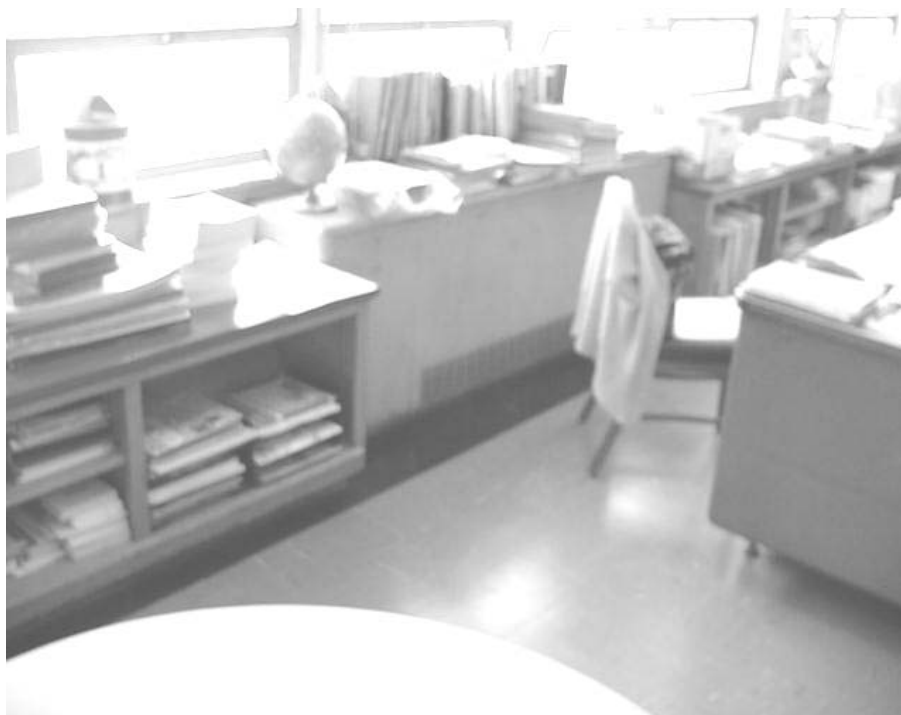
**Picture 6**

Fresh air in classrooms is supplied by a unit ventilator (univent) system (see [Picture 6](#)). A number of univents however were deactivated. Obstructions to airflow, such as paper and boxes stored on univent air diffusers and desks in front of univent return vents, were also noted in classrooms. In order for univents to provide fresh air as designed, univent air diffusers and return vents must remain free of obstructions. Importantly, these units must remain activated while classrooms are occupied.

**Univent, 1950s Wing**

5. Remove all blockages from univents to ensure adequate airflow. Clean interiors of univents regularly.
6. Examine mechanical exhaust vents throughout the building for function and activate if operable.

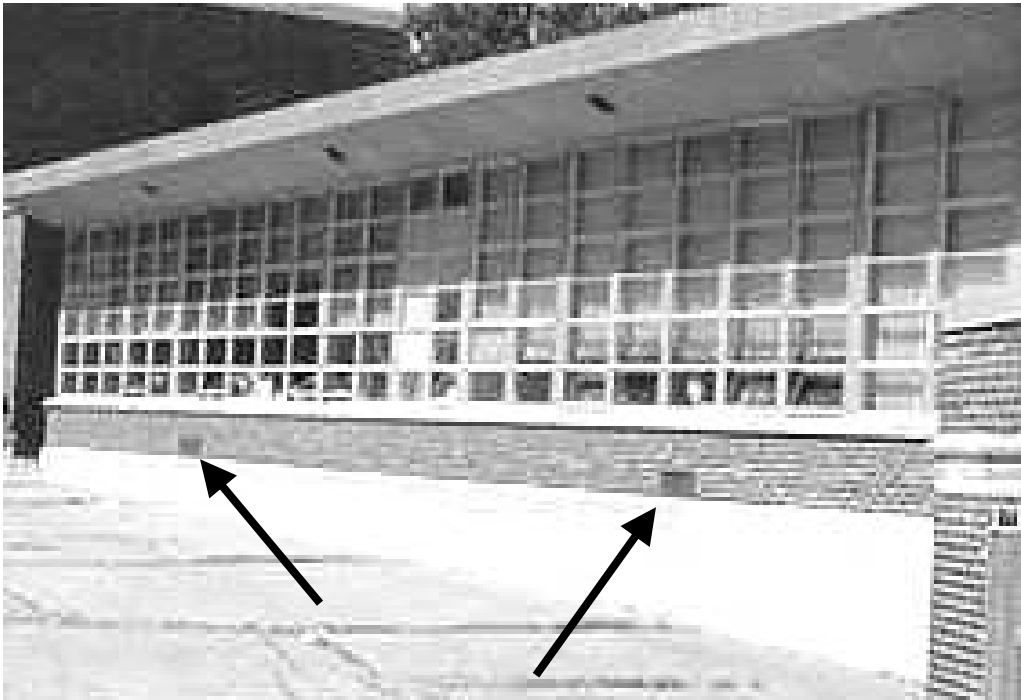
**Picture 7**

Please note that the basement art room and room 13 have mechanical ventilation equipment [unit ventilators (univents)]. Univents are designed to draw air from outdoors through a fresh air intake located on the exterior wall of the building and return air through an air intake located at the base of each unit (see Picture 7). Fresh air and return air are mixed, filtered, heated and provided to classrooms through a fresh air diffuser located on the front of the unit (see Figure 4). All of these univents were deactivated. An unnumbered classroom exists in the basement that has no mechanical vent system. Without an operating ventilation system, normally occurring indoor pollutants can be expected to build up in these areas.

**Univent Fresh Air Intakes**

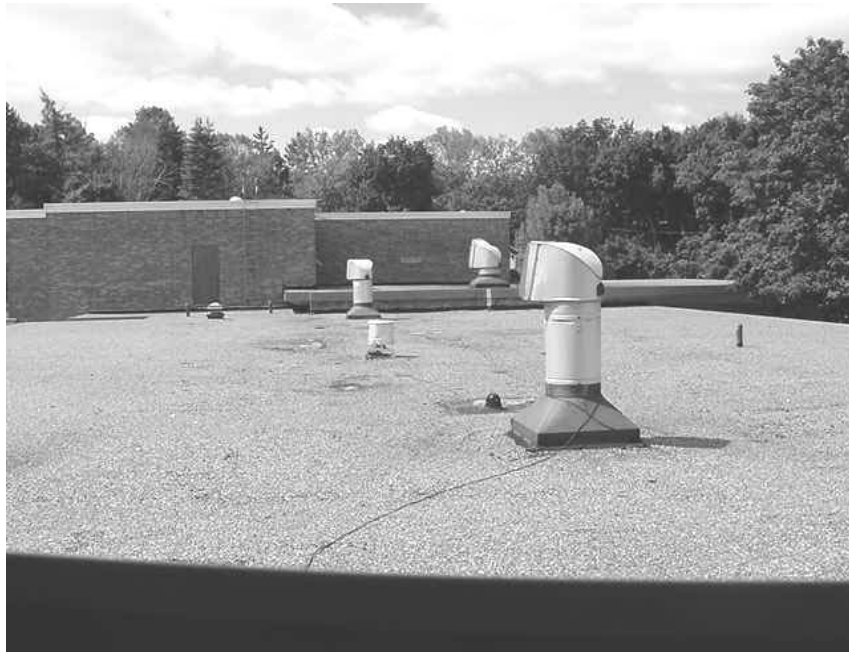
**Picture 8**

Exhaust ventilation is drawn from the classroom into a grated hole located within restrooms shared between classrooms. A flue located inside the duct controls airflow. Enhancing the draw of air up each exhaust vent is a revolving head roof ventilator (see Picture 8). The head of each vent is designed to rotate, with the fin keeping the opening facing away from wind, in a manner similar to a weather vane. The design of the vent creates negative pressure at the opening in windy conditions, which draws air up ductwork (Ulrey, H.F., 1966). The openings for each revolving head roof ventilator were not oriented opposite the prevailing

wind that day, which can indicate that some of the vent heads may not be freely rotating. In addition, both vents servicing the restrooms are missing their fins (see Picture 9 for comparison). Under certain wind direction, this condition can result in air being forced back down the duct, preventing these vents from exhausting odors.

**Revolving Head Roof Ventilators, 1950s Wing, Note Missing Fins On the Revolving Head Roof Ventilators in Foreground**

1. Examine the ability of each revolving head roof ventilator for free rotation. Repair each vent as needed.
2. Examine each univent for function. Survey classrooms for univent function to ascertain if an adequate air supply exists for each room. Consider consulting a heating, ventilation and air conditioning (HVAC) engineer concerning the calibration of univent fresh air control dampers school-wide.
3. Repair the pulley chain/louver door systems in vents to provide ventilation as designed. Repair the hinged-pulley system windows to provide fresh air to classrooms without

1. Based on the age, condition and availability of parts, the BEHA strongly recommends that an HVAC engineering firm evaluate the school's ventilation systems.
2. Consideration should be give to replacing the revolving head roof ventilators with mechanical fans to improve exhaust ventilation in the 1950s wing.
3. Examine the feasibility of restoring the original gravity feed ventilation system. This may entail repair or replacement of heating elements located in ventilation shafts; repair of broken or missing warm air and cool air pulley chain/louver door systems to provide ventilation in this building as designed; repair of the hinged-pulley system and/or installation of openable windows in basement area to provide fresh air to classrooms. If restoration is not an option, consideration should be given to installing a mechanical ventilation system in the original building.

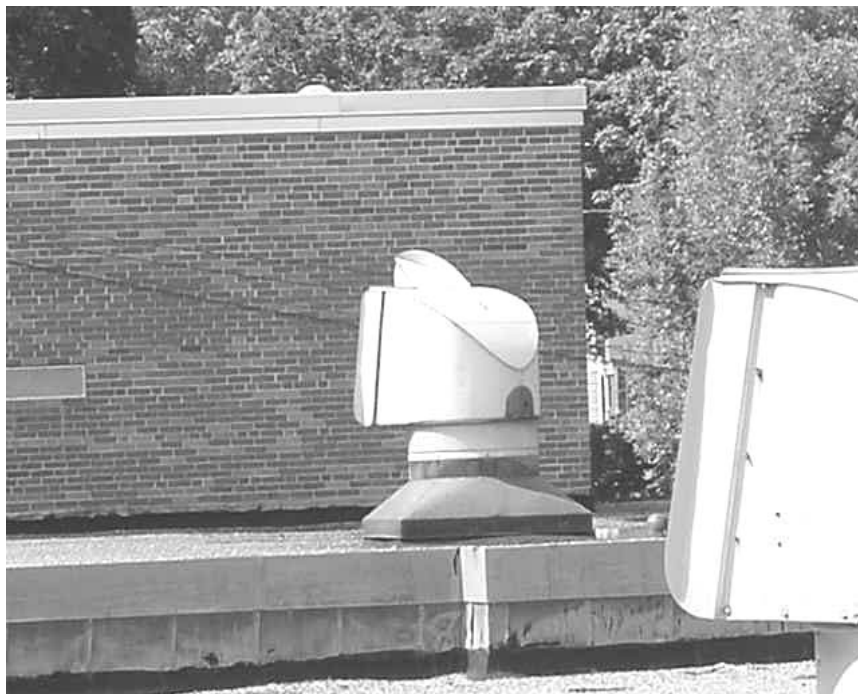
**Picture 9**

**Revolving Head Roof Ventilator with Fin Intact**

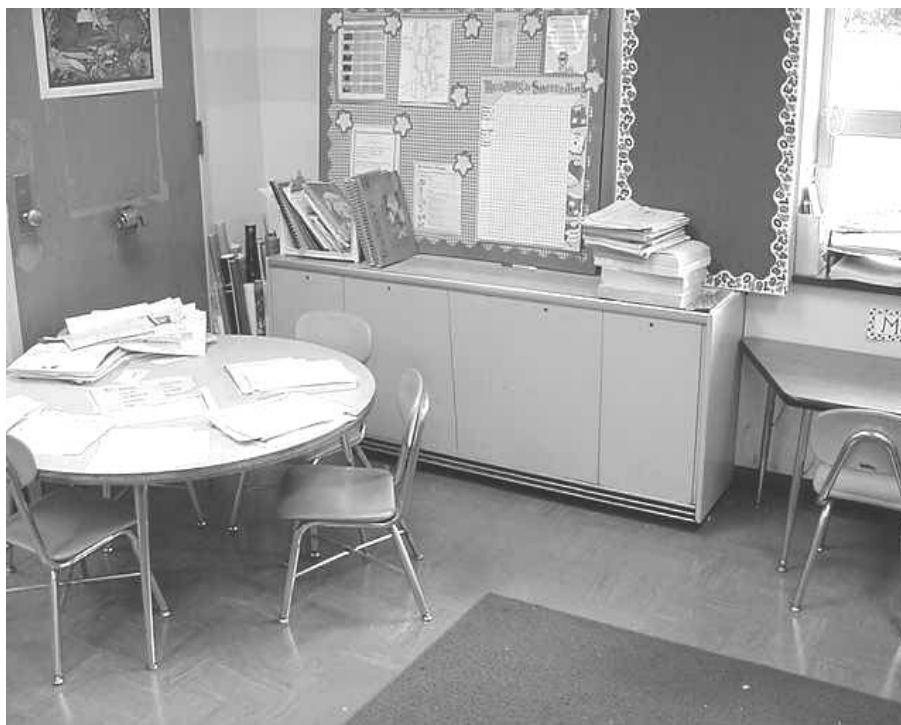
**Picture 10**

Fresh air for classrooms of the 1960's addition is also supplied by a univent system. As in the 1950's wing, obstructions to airflow (e.g. books, papers, boxes) were noted (see Picture 10). Exhaust ventilation is provided by a mechanical system, which draws air into an ungrated hole, located near floor level in classrooms (see Picture 11). Airflow is controlled by a flue located inside the duct. Some of these vents were blocked by recycling bins and other obstructions. As with the univents, in order for exhaust ventilation to function as designed, exhaust fans must be activated and remain free of obstructions.

**Univent, 1960s Wing**

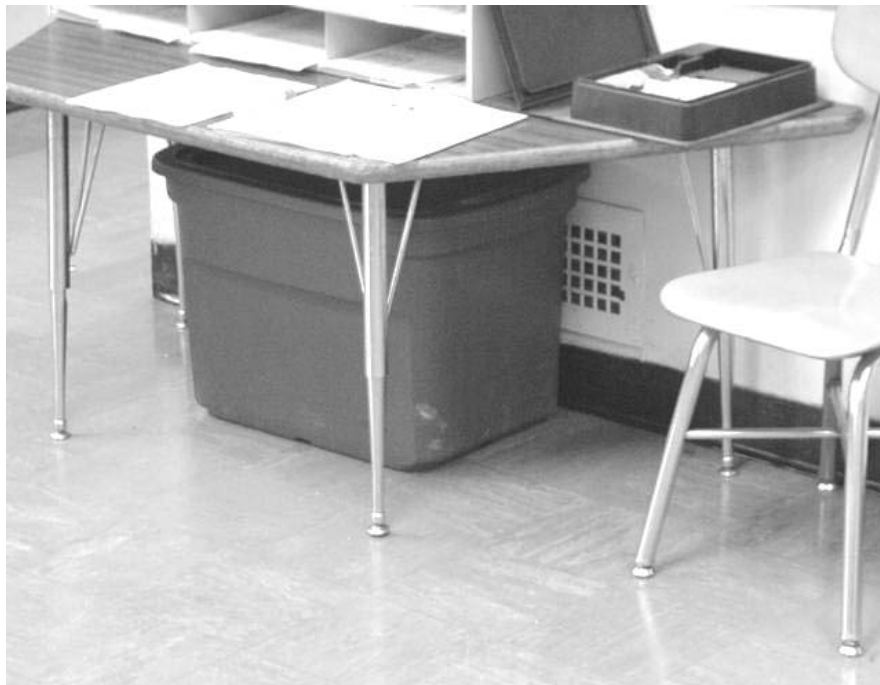
**Picture 11**

**Exhaust Vent, 1960s Wing, Note Blockage with Container**

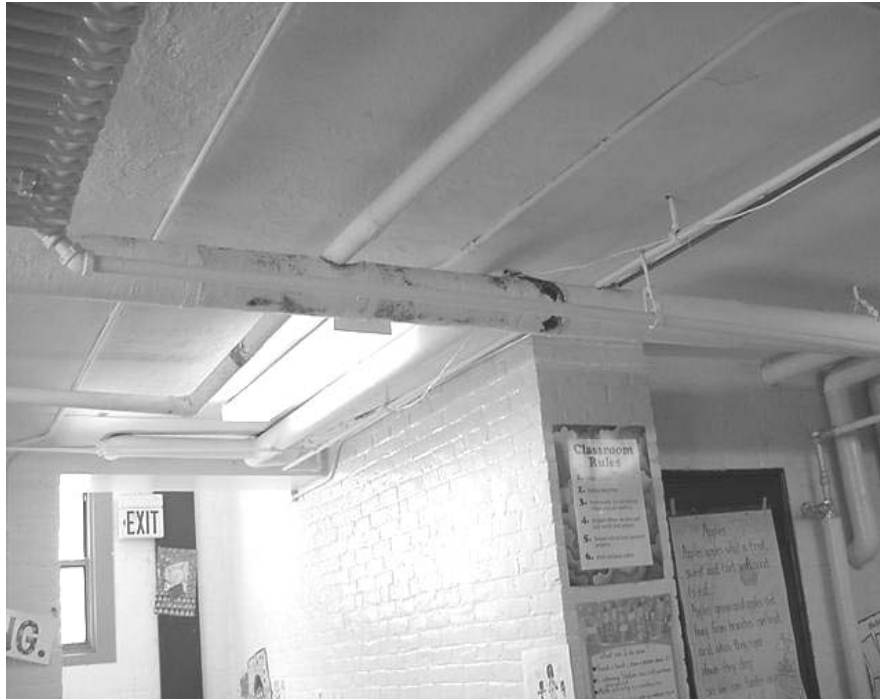
**Picture 12**

What appeared to be mold growth was noted on water-damaged pipe insulation in the art room and the unnumbered classroom in the basement of the original wing (see Picture 12).

Water-damaged insulation cannot be adequately cleaned to remove mold growth and should be replaced.

**Mold Contaminated Pipe Insulation**

9. Remove and replace mold colonized pipe insulation.
10. Ensure plants have drip pans. Examine drip pans periodically for mold growth and disinfect with an appropriate antimicrobial where necessary. Do not put plants directly on carpeting.

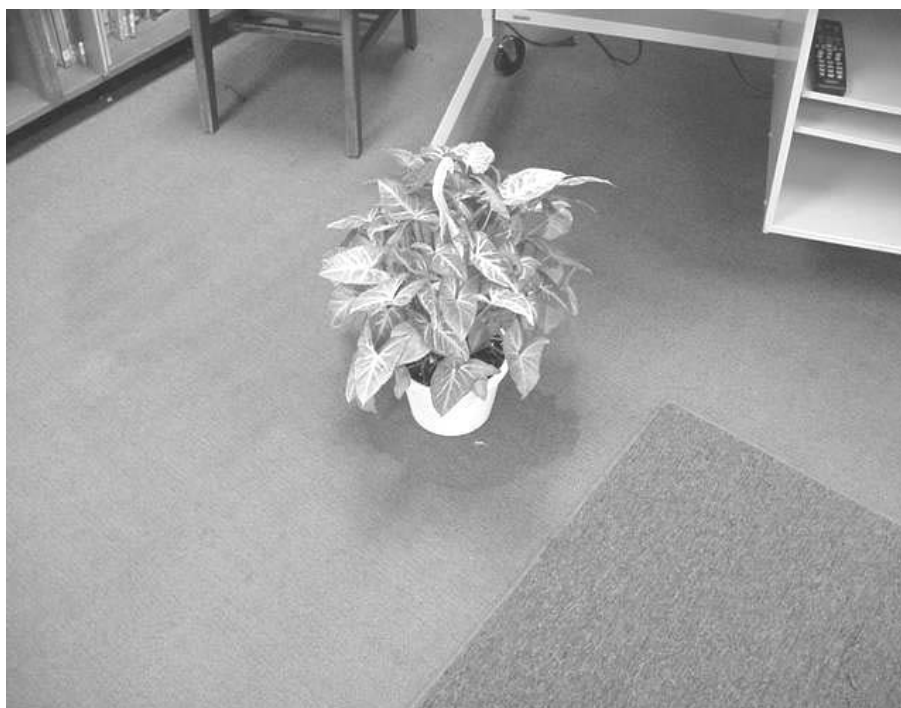
**Picture 13**

Plants were noted in several classrooms, the library had plants on top of carpeting (see Picture 13). Plants can be a source of pollen and mold, which can be respiratory irritants for some individuals. Plants should be properly maintained and equipped with drip pans. Plants should also be located away from univents to prevent the aerosolization of dirt, pollen or mold. The American Conference of Governmental Industrial Hygienists (ACGIH) recommends that carpeting be dried with fans and heating within 24 hours of becoming wet (ACGIH, 1989). If carpets are not dried within this time frame, mold growth may occur. Once mold has colonized porous materials, they are difficult to clean and should be removed.

**Plant on Carpet in Library**

4. Remove plants in contact with wall-to-wall carpeting in library. If carpeting is moldy, remove this material a manner consistent with US EPA recommendations for mold remediation (US EPA, 2001).

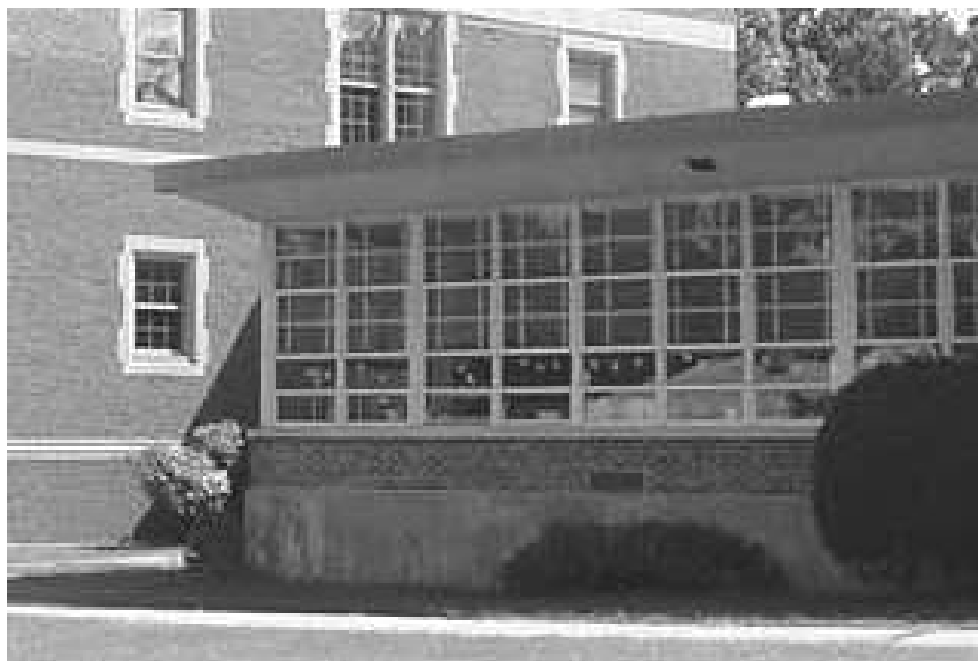
**Picture 14**

Along the perimeter of the building, shrubbery and flowering plants were noted in close proximity to univent fresh air intakes (see Picture 14). Shrubby and flowering plants can be sources of mold and pollen and should be placed and/or maintained to ensure that fresh air intakes remain clear of obstructions to prevent the entrainment of dirt, pollen or mold into the building

**Shrubbery in Close Proximity to Fresh Air Intake**

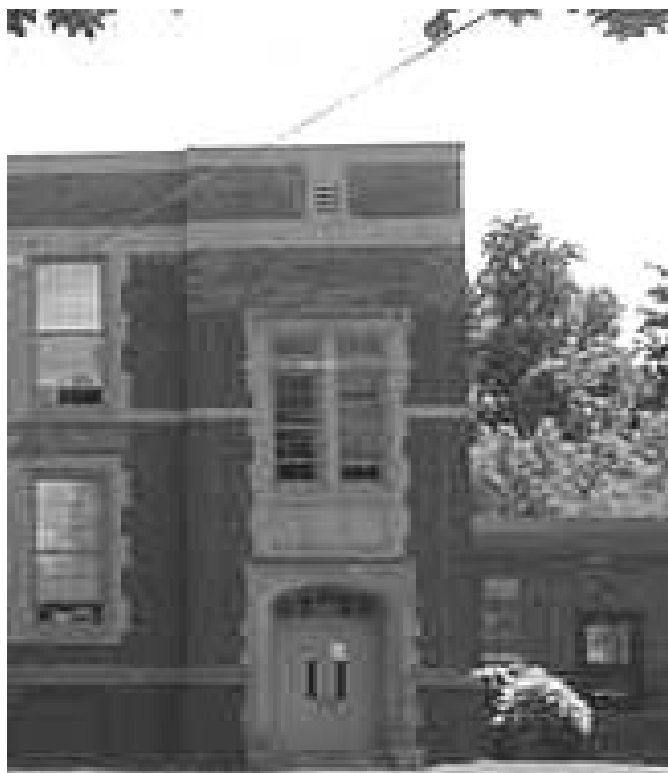
**Picture 15**

Shrubby also exists in close proximity to the foundation walls (see Picture 15). The growth of roots against the exterior walls can bring moisture in contact with wall brick and eventually lead to cracks and/or fissures in the foundation below ground level. Over time, this process can undermine the integrity of the building envelope and provide a means of water entry

into the building through capillary action through foundation concrete and masonry (Lstiburek, J. & Brennan, T.; 2001).

**Shrubbery in Close Proximity to Exterior Wall, Original Wing**

11. Move foliage to no less than five feet from the foundation.
12. Consider relocating photocopiers to a well-ventilated area or examine the feasibility of installing local exhaust ventilation.
13. Clean chalkboards and trays regularly to prevent the build-up of excessive chalk dust.
14. Store the snow blower in an area with adequate ventilation that will prevent VOC migration into occupied areas.
15. Relocate or consider reducing the amount of materials stored in classrooms to allow for more thorough cleaning. Clean items regularly with a wet cloth or sponge to prevent excessive dust build-up.

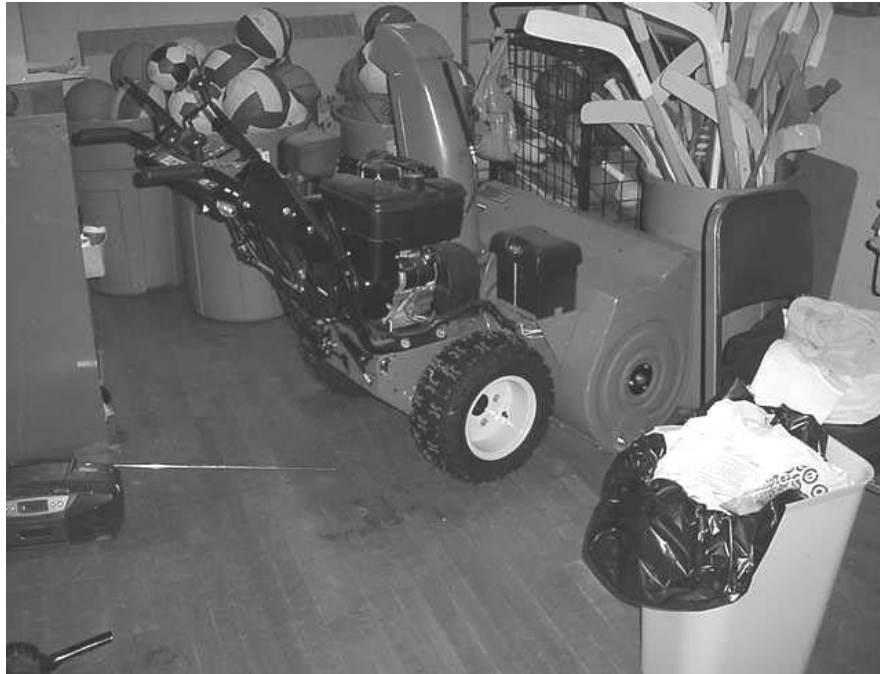
**Picture 16**

Several other conditions were noted during the assessment that can affect indoor air quality. A snow blower was stored in the gymnasium (see Picture 16). Gasoline vapors can off-gas from the snow blower and result in volatile organic compounds (VOCs) being introduced into the occupied space of the building. Gasoline is a mixture that contains VOCs that can acutely be irritating to the eyes, nose and throat. Gasoline containing vehicles and equipment should be stored in an area with continuous local exhaust ventilation to prevent the build-up of flammable vapors indoors.

**Snow Blower Stored in Gymnasium**
